Deer Creek Erosion Control Project

FINAL REPORT

California State University, Chico Research Foundation

August, 2001

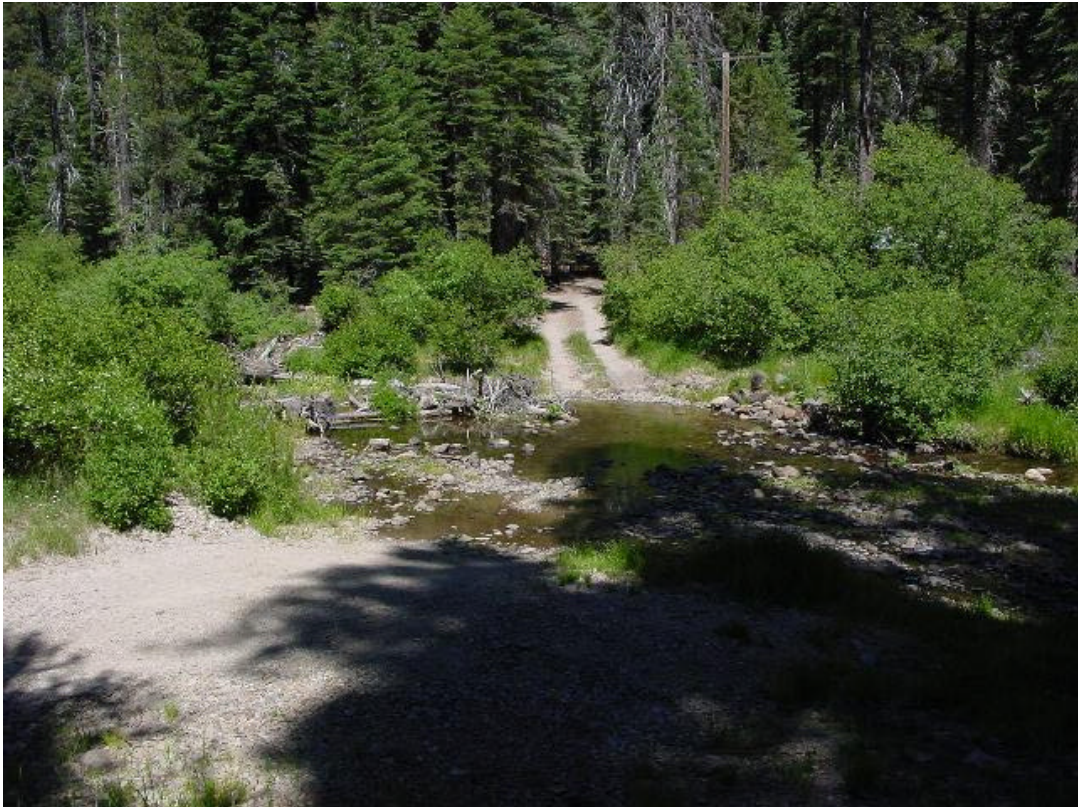
Photo 1.a

Gurnsey Creek Ford—Willis Road

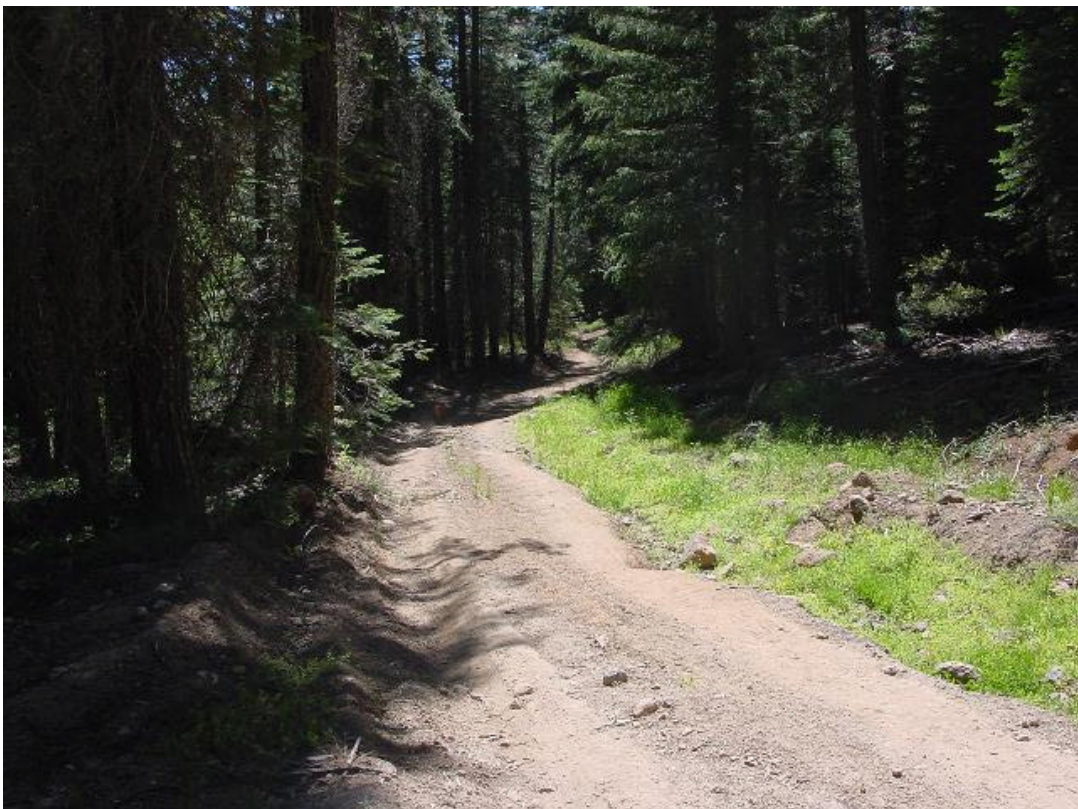
Photo 1.b

Spring seep along the Willis Road

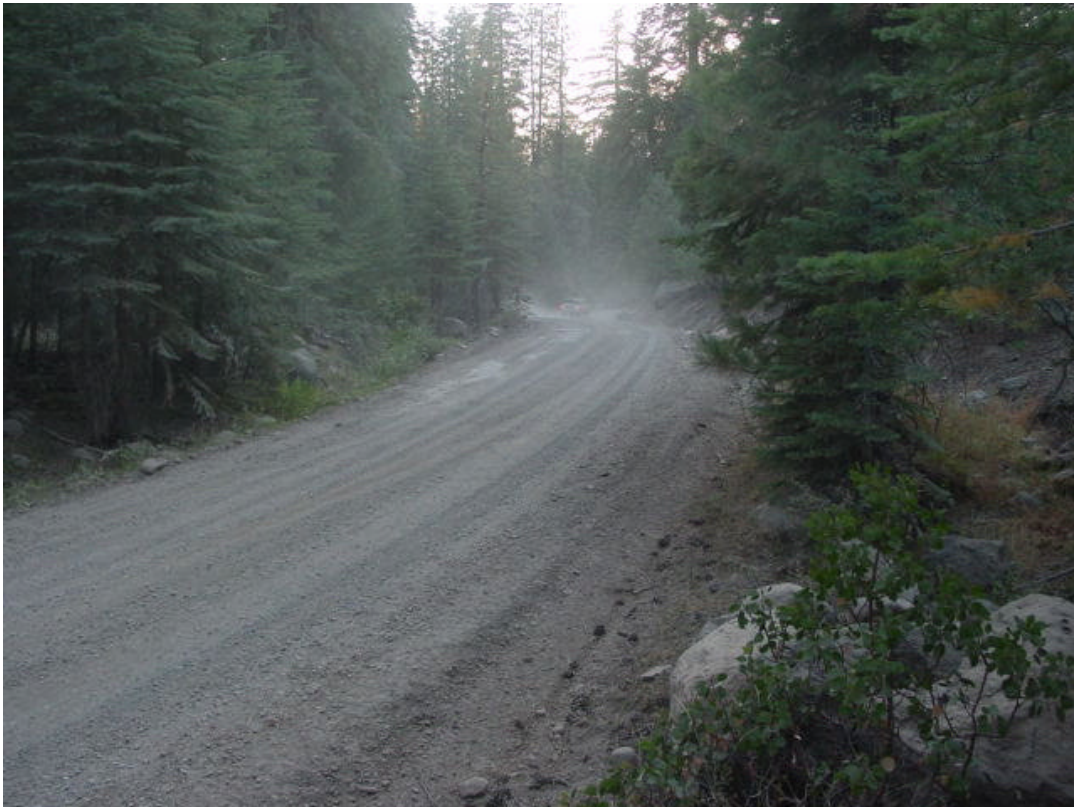
Photo 2.a

General Description: A section of the Tehama County Road west of Wilson Lake runs through USFS ownership and immediately adjacent to the bottom of an unnamed drainage. This section of county road is described as: beginning at the SE1/16th. Corner of Section 30, T.29N., R.5E., and running eastward on the Wilson lake County Road to its crossing of the Collins 900 Road near the south boundary of the NESW of Section 29, T.29N., R.5E., approximately 3,800 lineal feet. During high runoff conditions, this road segment becomes the active stream channel. The USFS would like to relocate the county road away from this drainage on their ownership. Coincidentally an existing parallel road exists (Collins 900 Spur) that would provide better separation from this drainage and allow the troublesome segment of county road to be abandoned.

Site 2: Wilson Lake County Road

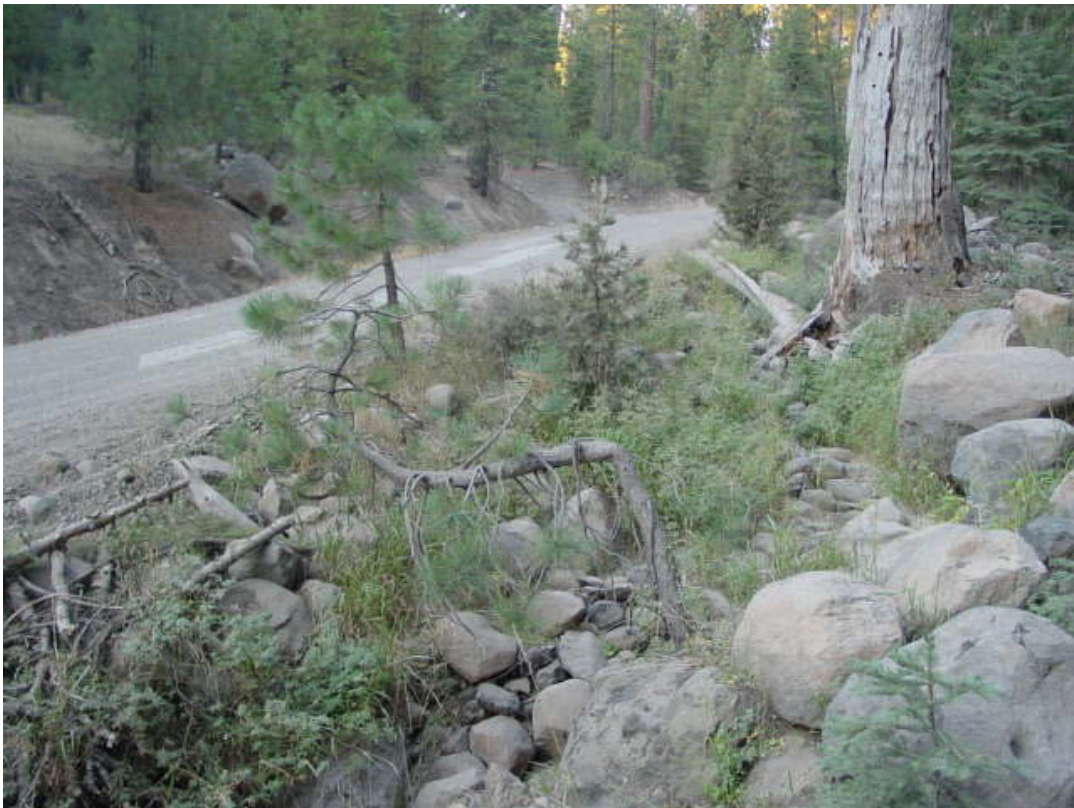
Photo 2.b

Site 2: Wilson Lake County Road

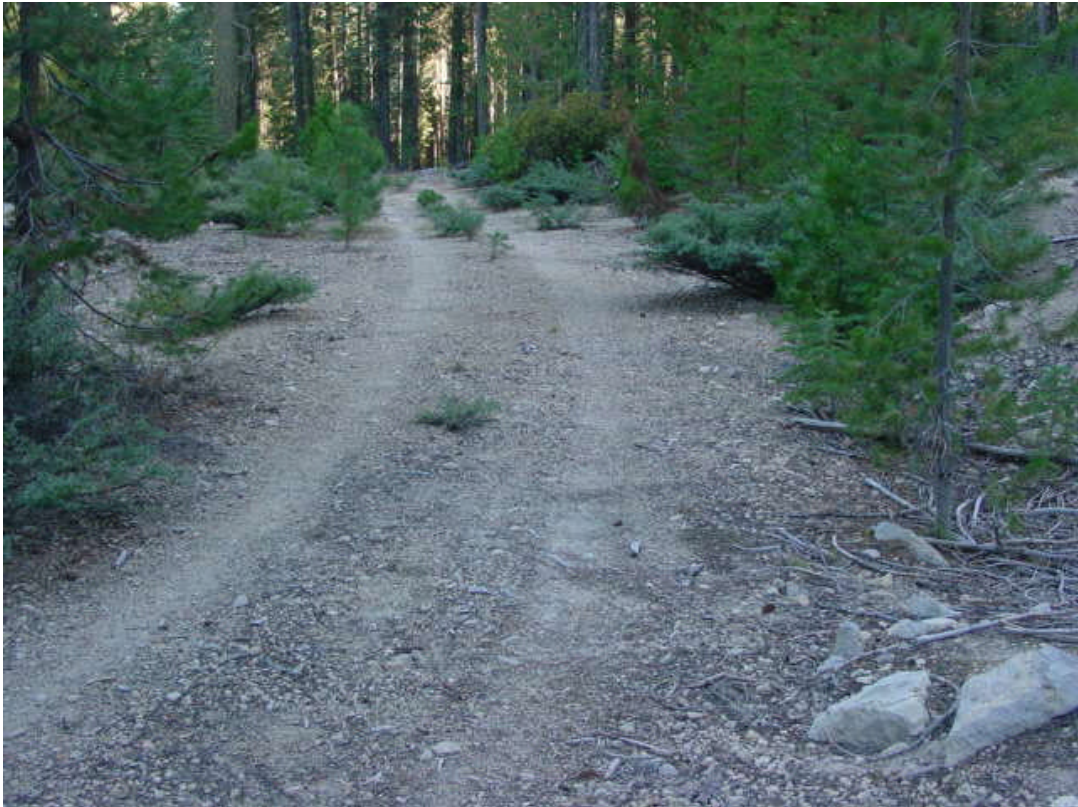
Photo 3.a

Specifics: Field inspection indicates very little active erosion at the end of this road on USFS property. Much of the end of this road is now converting to white thorn brush cover and has a high woody material cover. Recommend not disturbing this healing process on USFS ownership by exposing more bare soil through equipment activity. Tank trap the lower end at the property line and treat the front end of the road, on Collins ownership, as a skid road with numerous standard water bars, eighty (80) feet apart. Install a standard tank trap at the junction of the main 1500 road to prevent passage by motor vehicles, until the next Collins harvest cycle.

1550 Road entering USFS ownership.

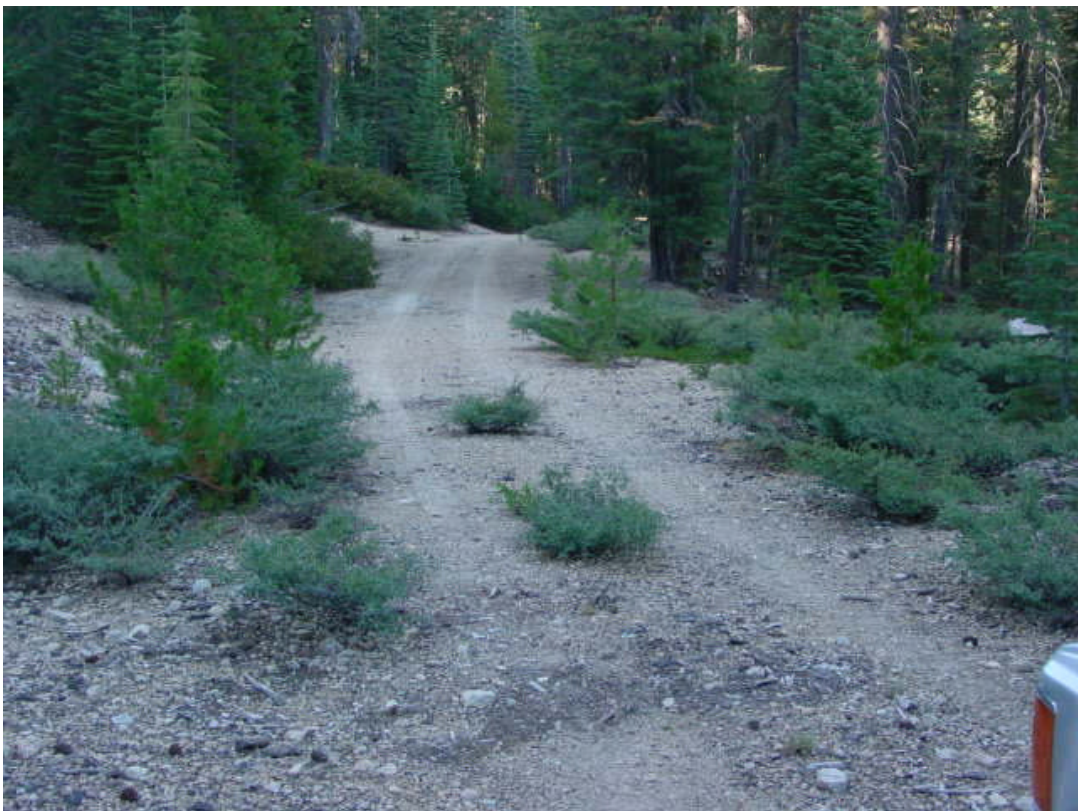
Photo 3.b

1550 Road with natural vegetation.

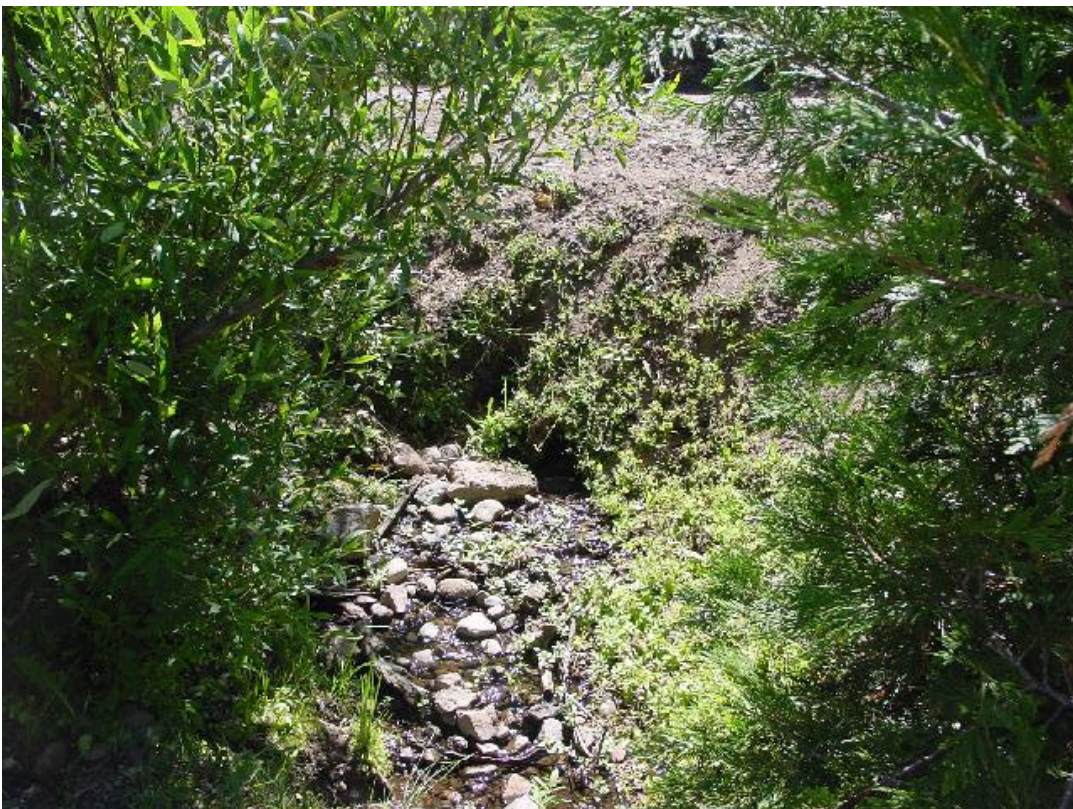
Photo 4.1a

Site 4.1—Culvert—upstream view

Site 4-1: Replace existing CMP with 18" x 36' CMP

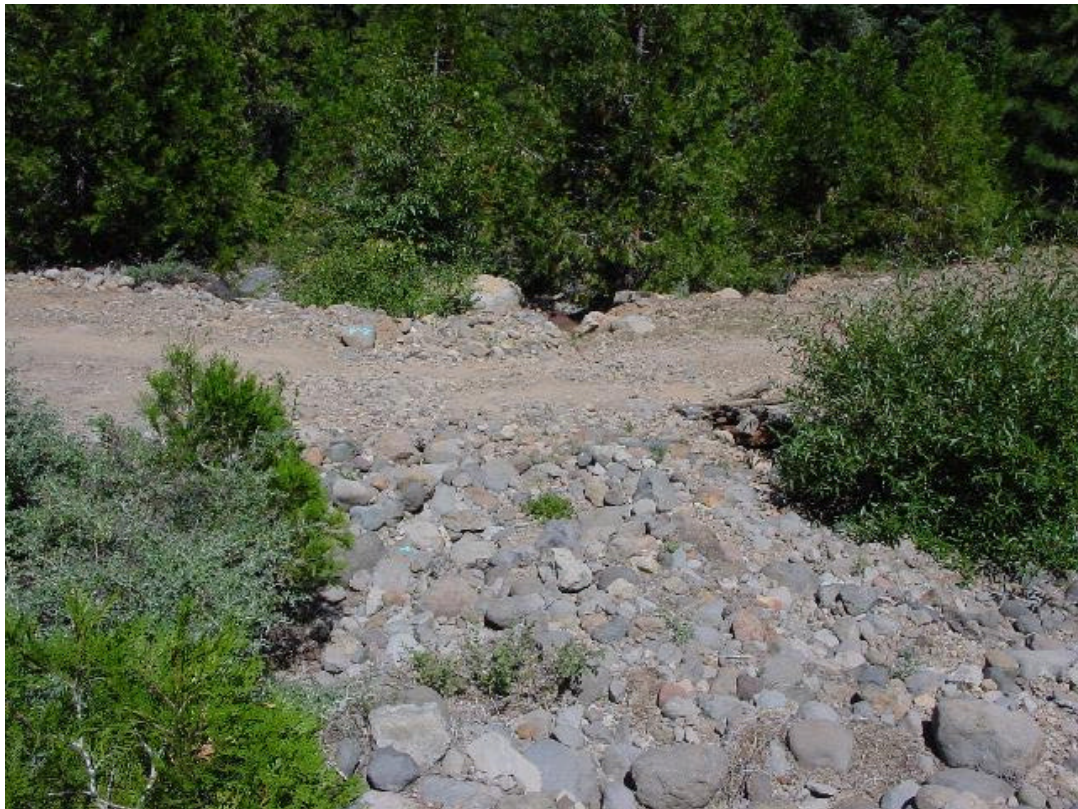
Photo 4.2a

Site 4.2—Culvert—Upstream

Site 4-2: Replace existing 18" CMP with 48" CMP or low water ford. Low water ford must be heavily rip rapped or of impervious material, i.e. concrete. Road forms 4.5 foot drop below drainage crossing which requires major energy dissipater in light of potential discharge or extended dip to road grade. Culvert is recommended.

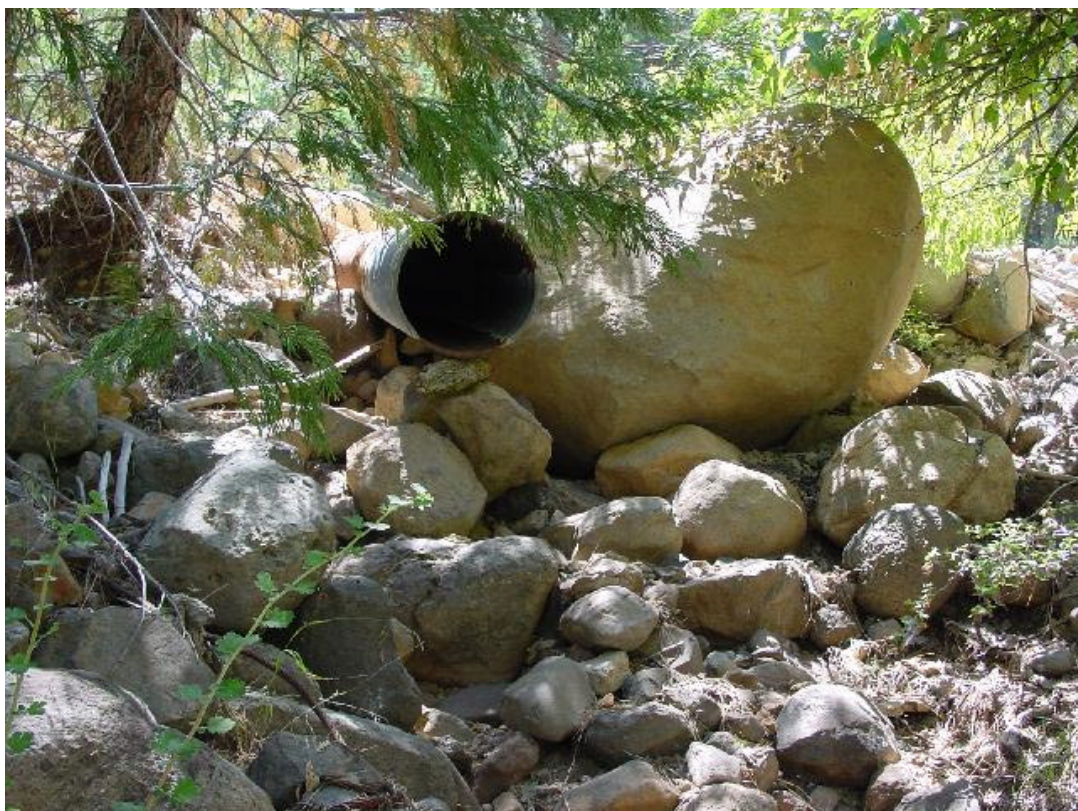
Photo 4.2b

Site 4.2—downstream view

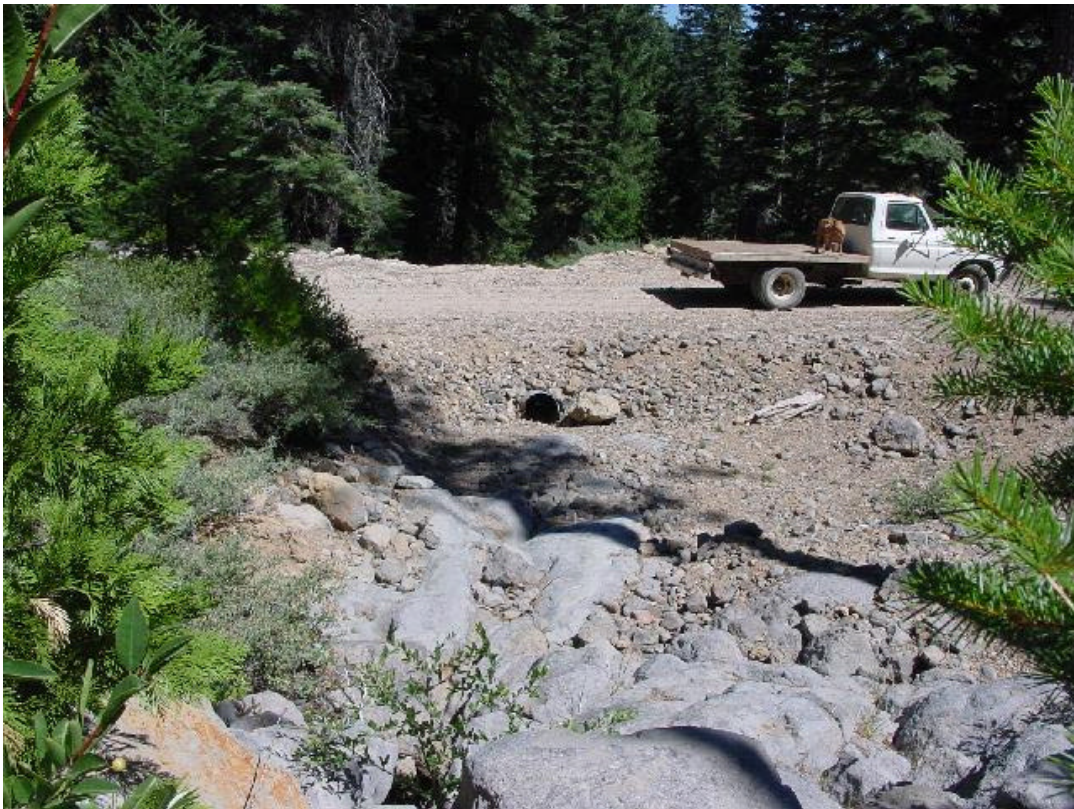
Photo 4.3a

Site 4.3—Culvert—upstream view

Site: 4-3 Replace existing 12" CMP with 54" CMP or low water ford.

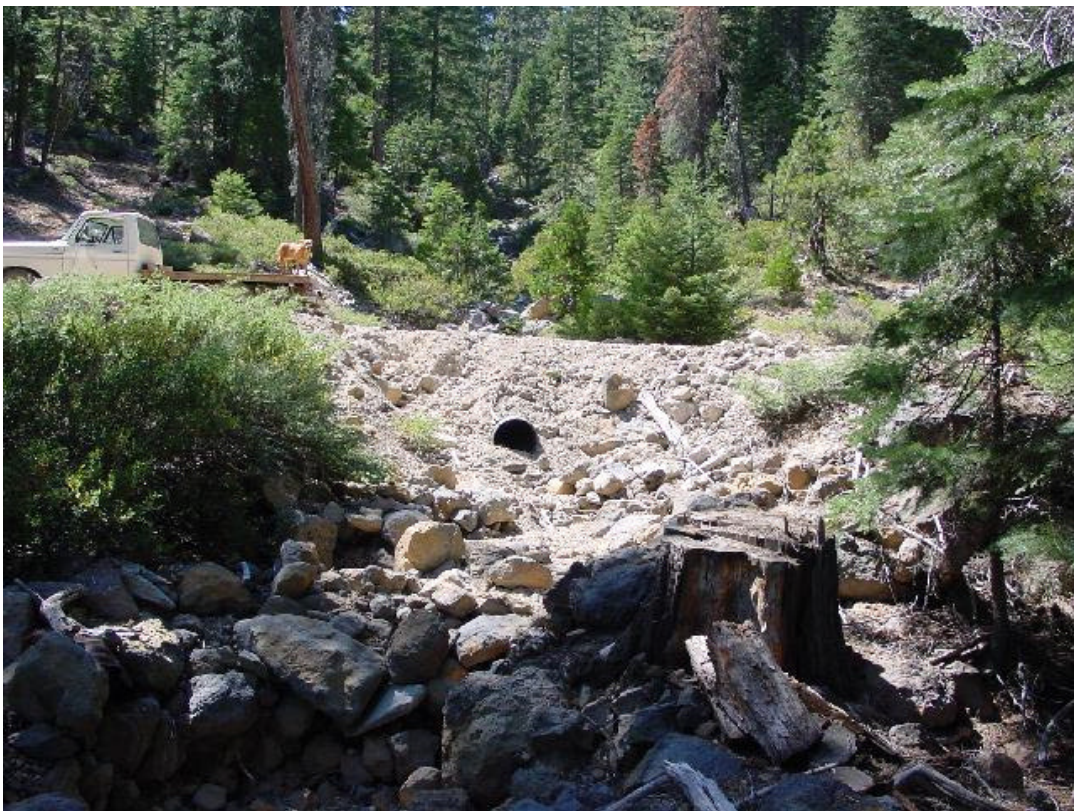
Photo 4.3b

Site 4.3—Culvert—downstream view

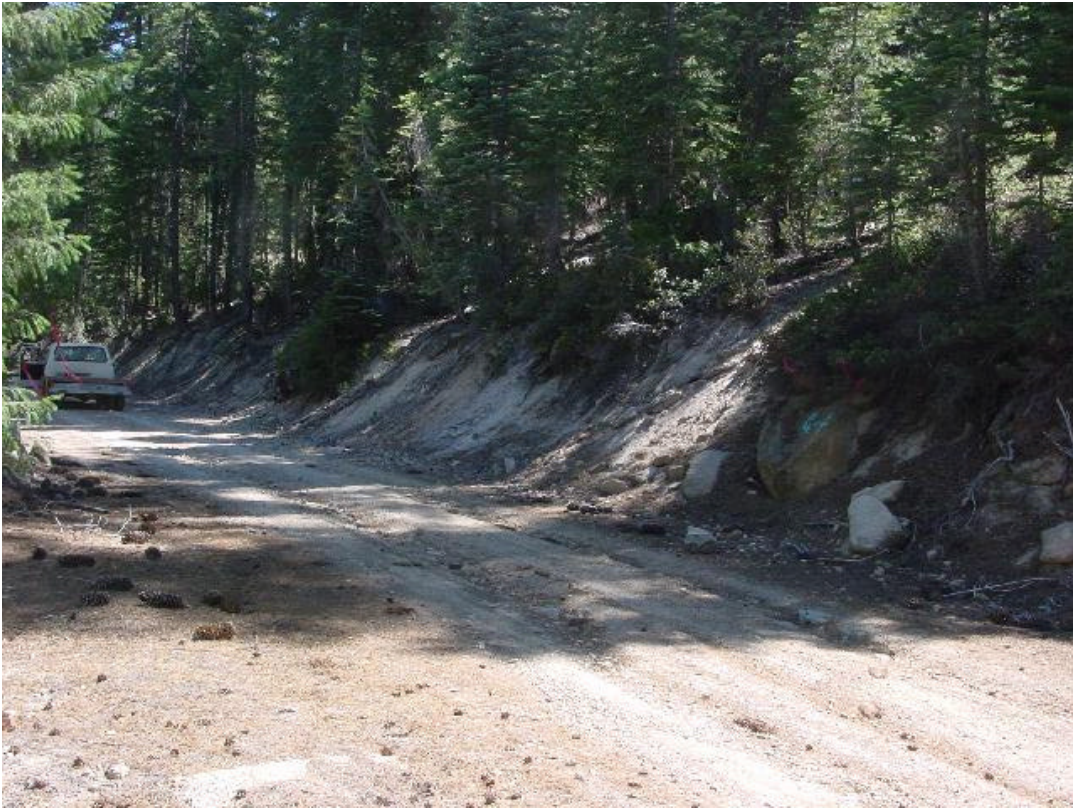
Photo 4.4a

Site: 4-4 Active rill erosion on road surface. Needs rolling dip but requires energy dissipater below. Photo 4.g—1500 Road Site 4.4—Water damage from skid trail above 1500 road

Site 4.4—Water damage from skid trail above 1500 road

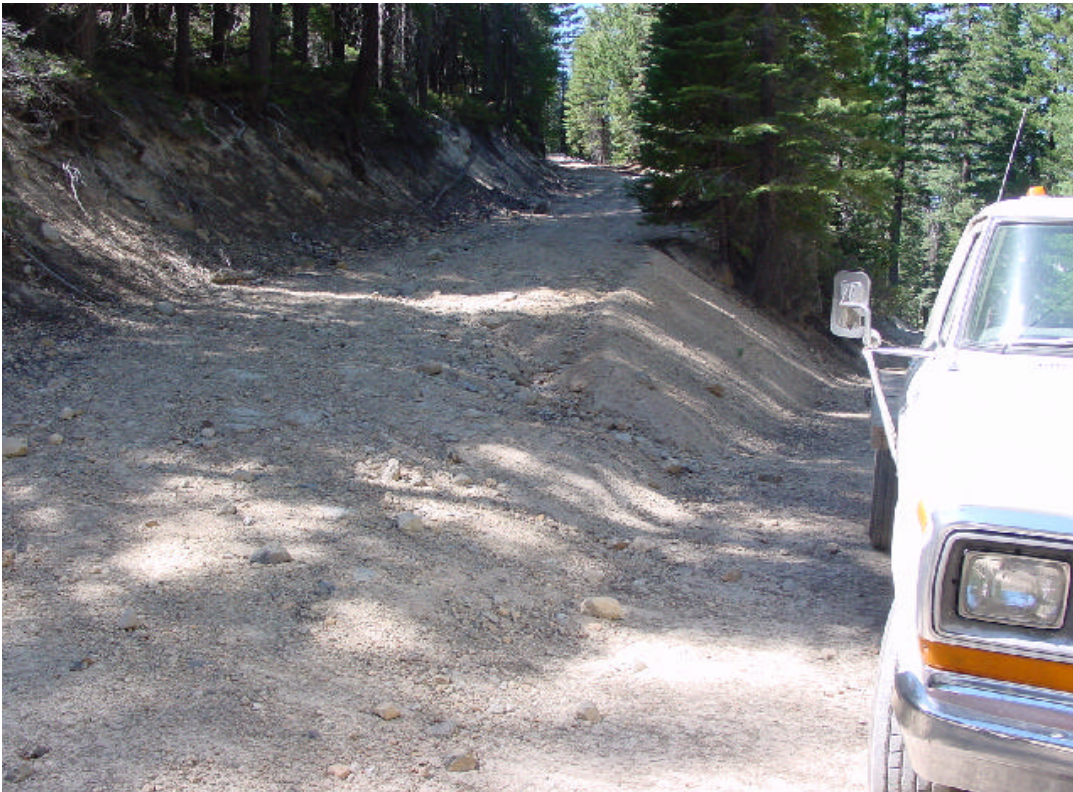
Photo 4.5a

Site 4.5—Erosion at junction of 1560 spur road

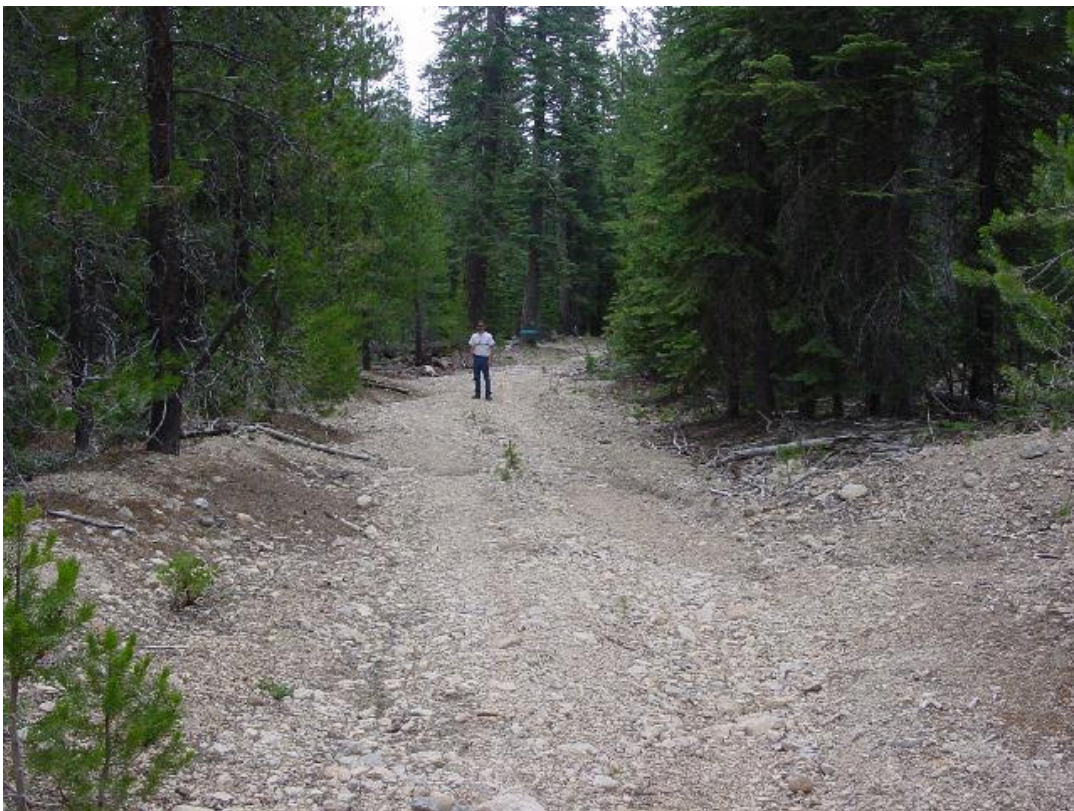
Photo 5.a

Site 5: Road 1545-1—Water source that initiated head cut..

Goals: Abandon existing road and encourage filling of head cut to natural conditions

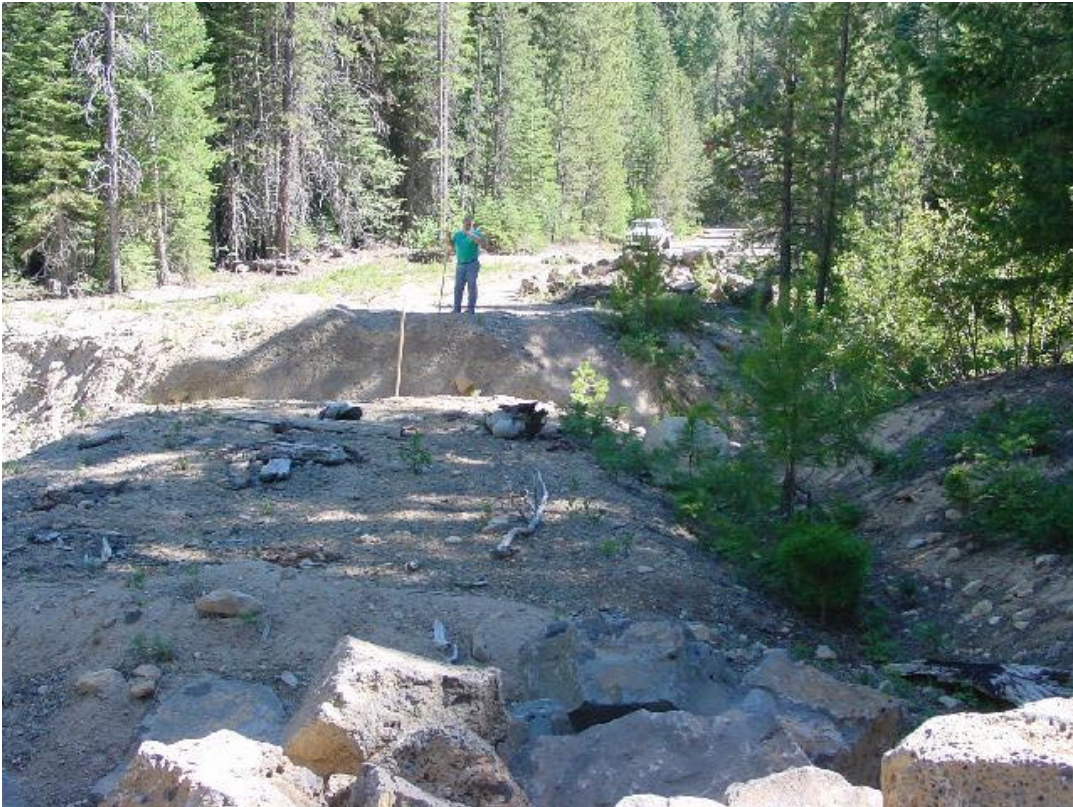
Photo 6.a

General Description: This unnamed tributary of Gurnsey Creek has repeatedly plugged or exceeded the capacity of various sized culverts three times in the last 25 years. High flows in this creek produce high bed load movement placing culverts vulnerable to plugging. This stream flows all year and supports spawning and rearing of juvenile native salmonids. Most of the original road fill has already washed downstream. Left alone, little additional sedimentation is likely to occur. However, the north end of the 1500 road is blocked to heavy truck traffic and repair is desired.

Site 6: 1500 Road—Failed stream crossing.

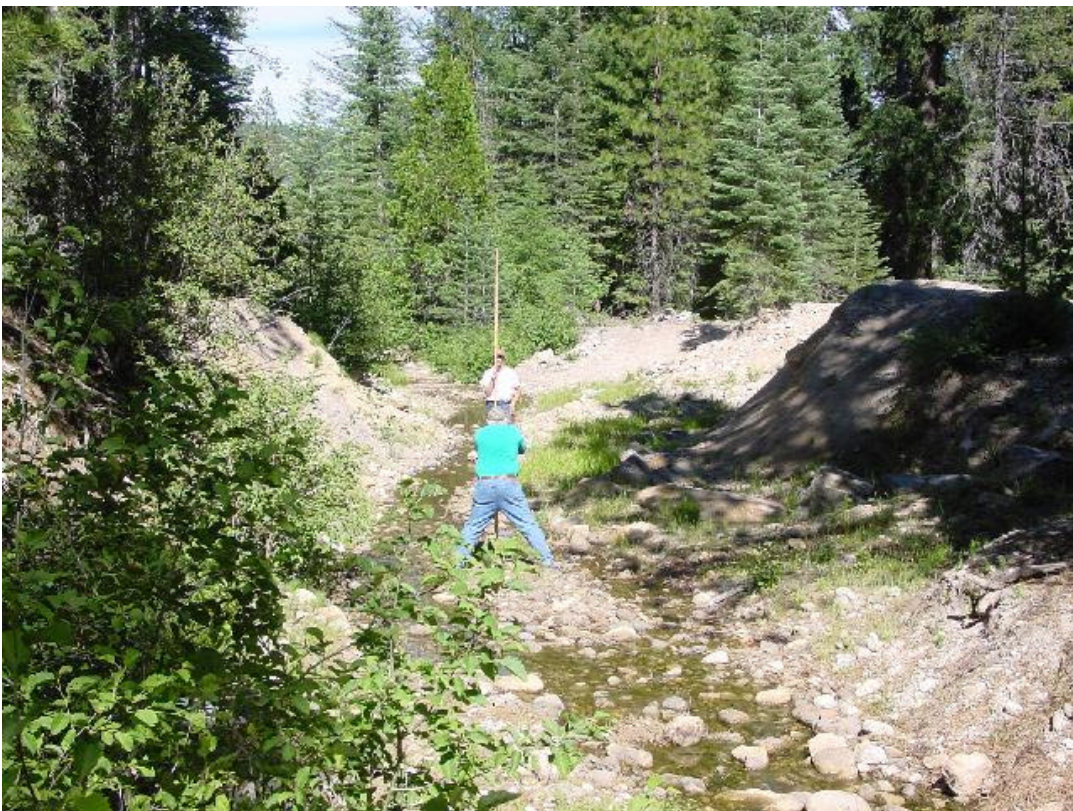
Photo 6.b

Site 6: 1500 Road—Failed stream crossing; looking downstream

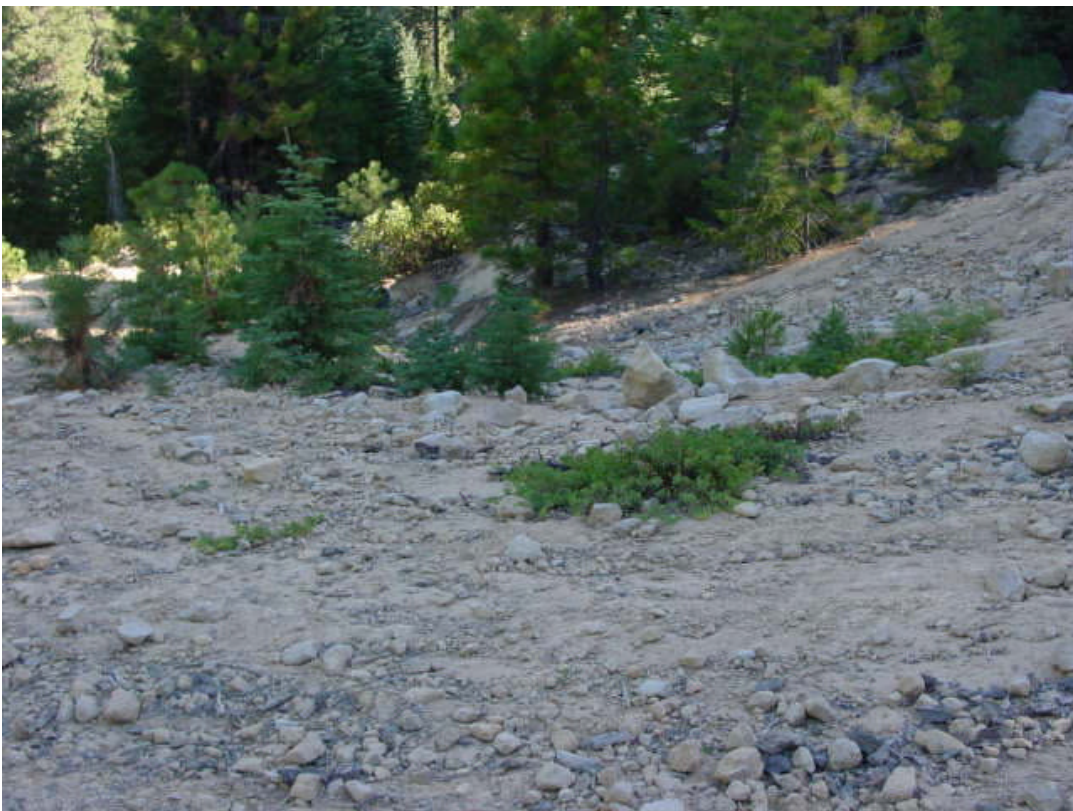
Photo 7.a

Site 7: 1510 Road—Well established ditch vegetation.

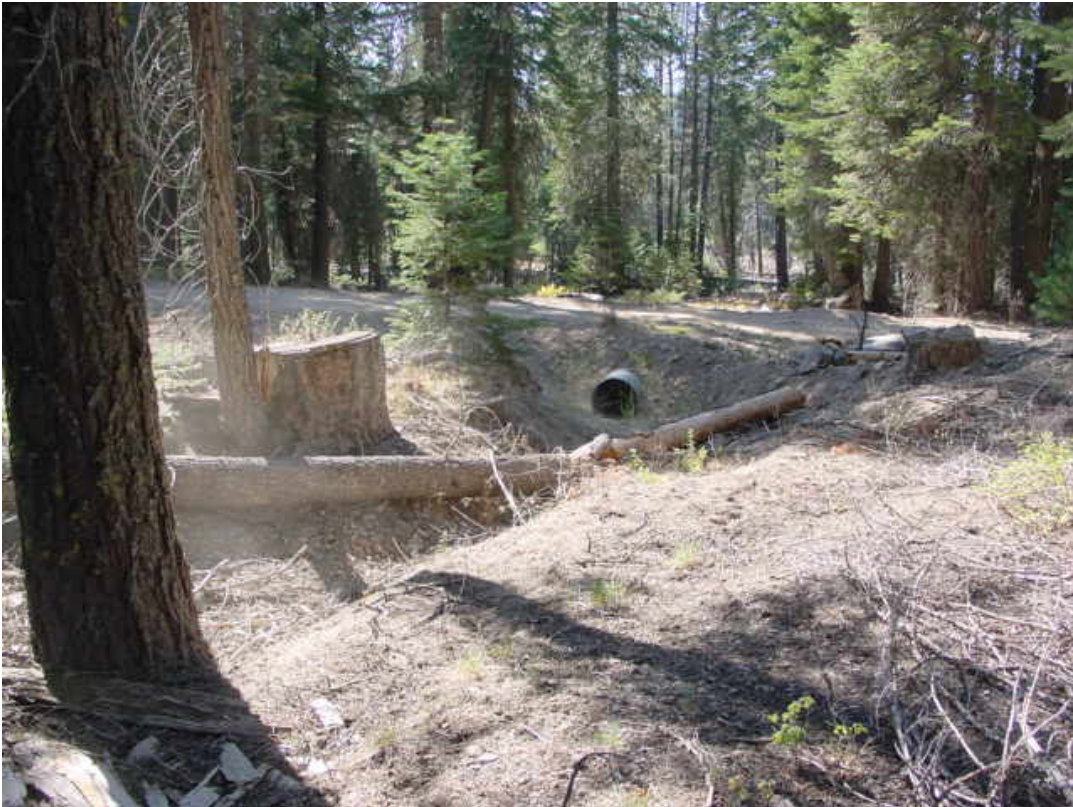
Photo 8.a

Photo 8.a—1400 Road—Site of proposed low-water ford.

Goals: Replace the culvert with a standard low-water ford, obliterate the road ditch, and out slope the entire road segment. Block off-road traffic to the banks of Gurnsey Creek with large cull logs or large native rocks.

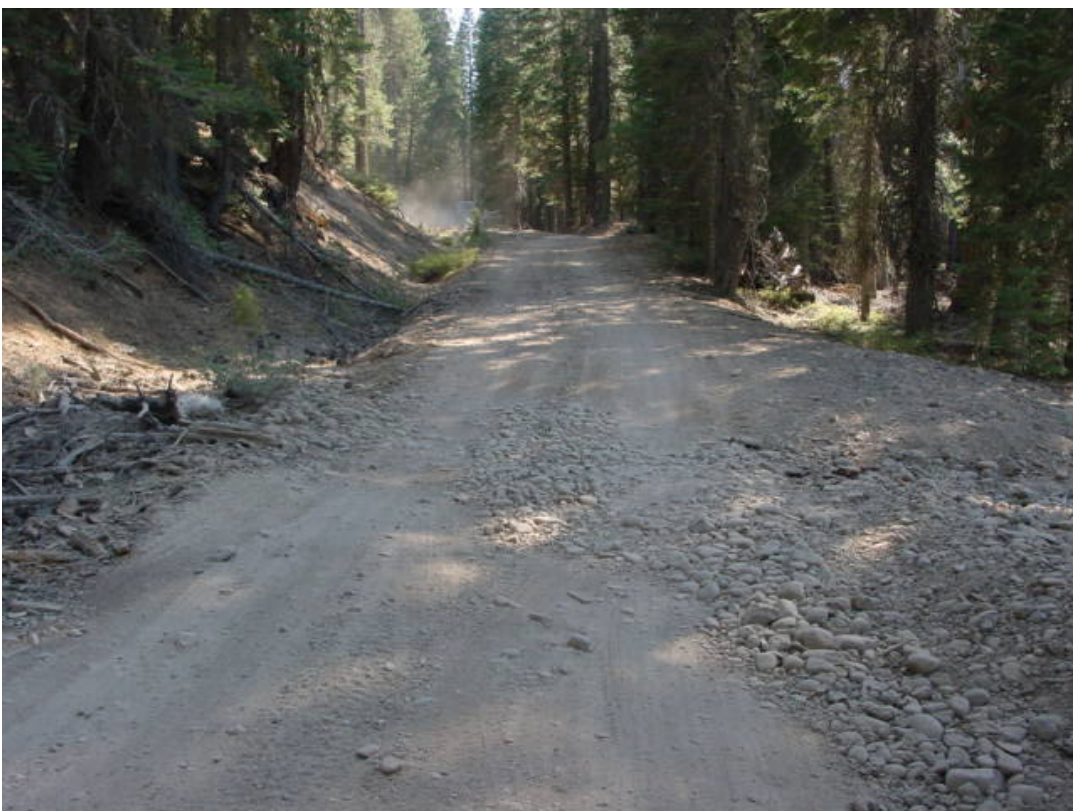
Photo 8.b

General Description: Road surface erosion at a minor tributary crossing was inspected. The primary cause of this erosion is excessive water flow down the road surface from poor drainage structures. A plugged culvert diverted water onto the road surface, until it finally exited via an out sloped section

Photo 8.b—1400 Road—Erosion after culvert failure.

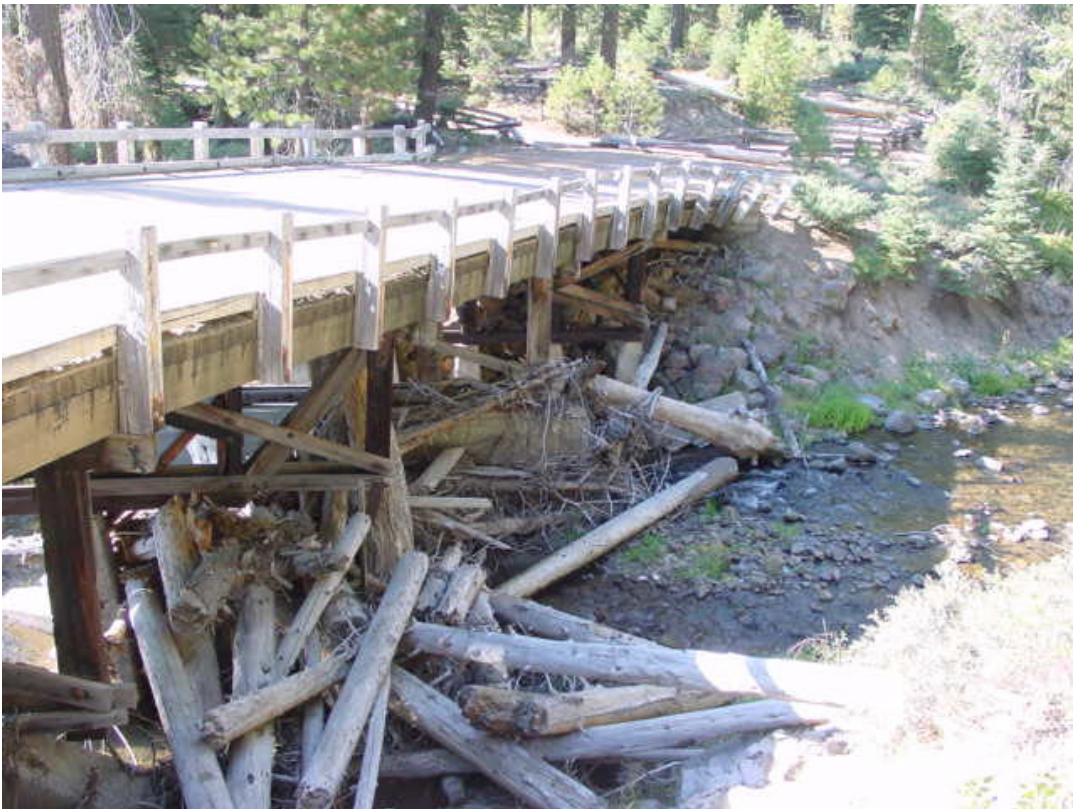
9.a

General Description: A portion of Highway 36 was quitclaimed back to the Collins Almanor Forest owners, after the Christmas 1964 flood. A wood structure bridge, across the North Fork of Deer Creek, is part of this quitclaimed segment. The supports for this bridge have been damaged in repeated high flows. A future high flow will likely cause the bridge to collapse sideways into the stream channel. The resulting blockage would cause the stream to back up, until it flowed around the 'dam'. Channel and bank erosion from this might be significant.

Site 9: Log Jam Above Old Hwy 36 Bridge

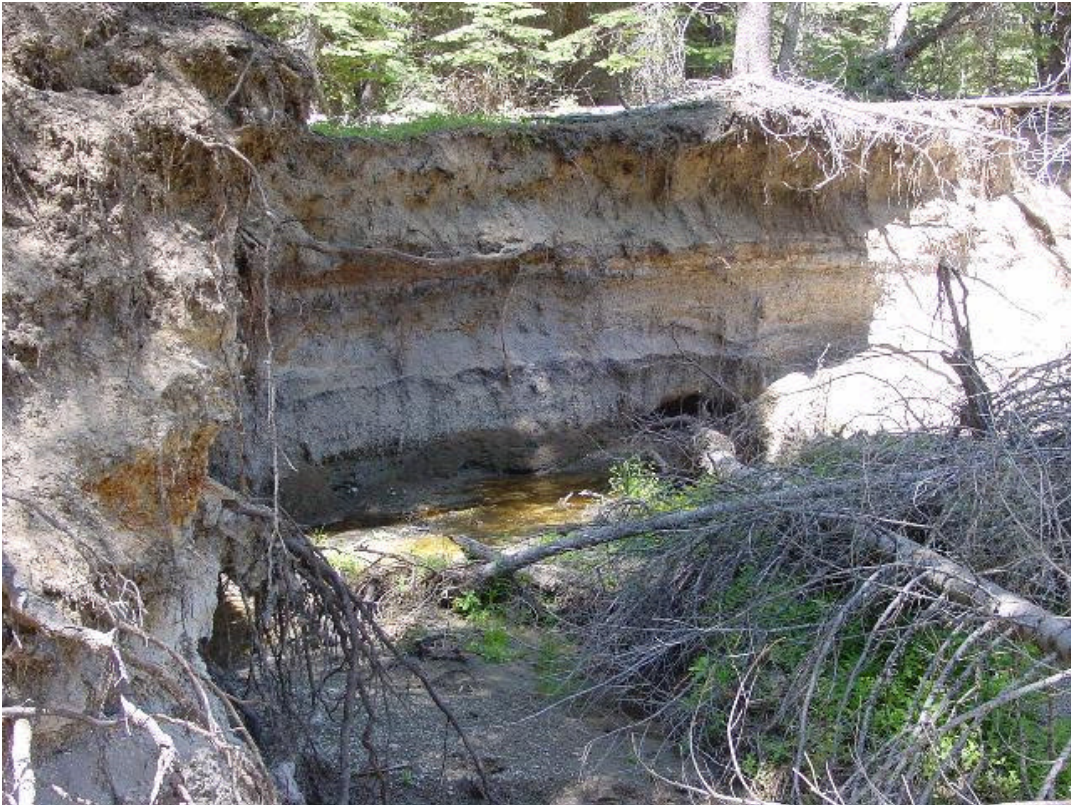
Photo 10.h

Photo #10h: Spring activity in stream bank immediately below previous photo has resulted in accelerated bank erosion. This highlights the effect of soil moisture (at field capacity) in accelerating mass movement in rhyolite soils.

1422 Spur road—Spring caused vertical bank

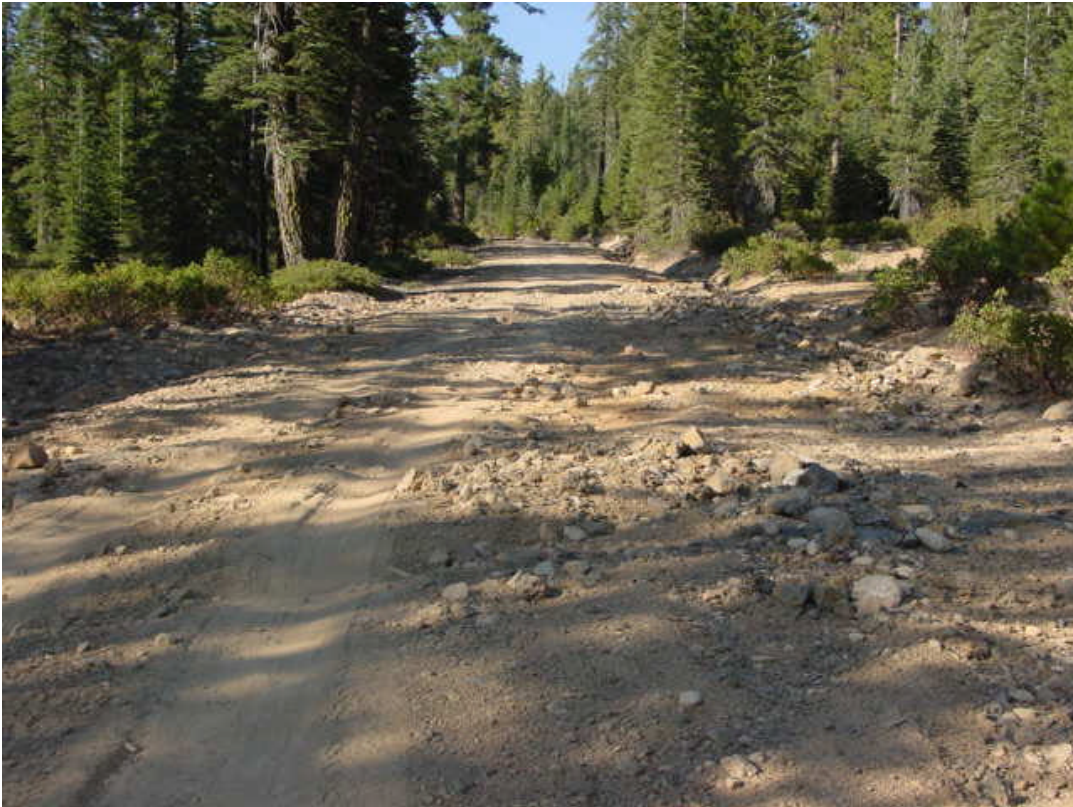
Photo 14.a

Site 14: 1700 Road damage from plugged cross drain

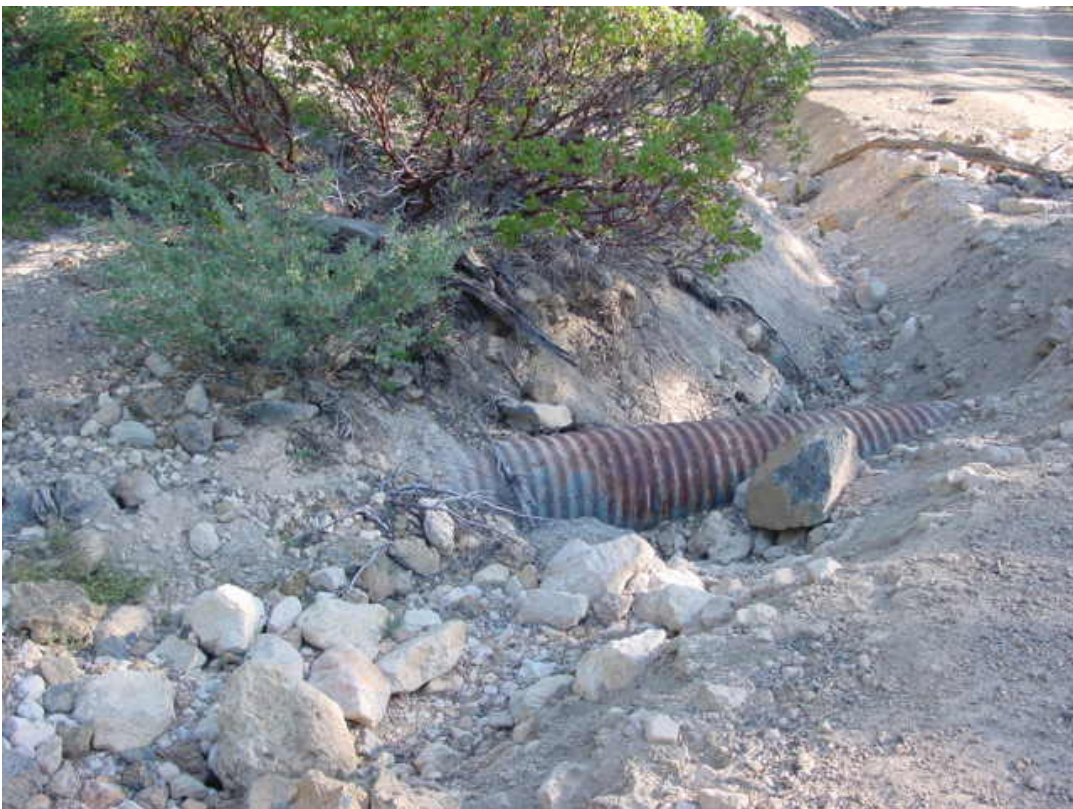
Photo 14.d

Site 14: 1700 Road - Plugged cross drain

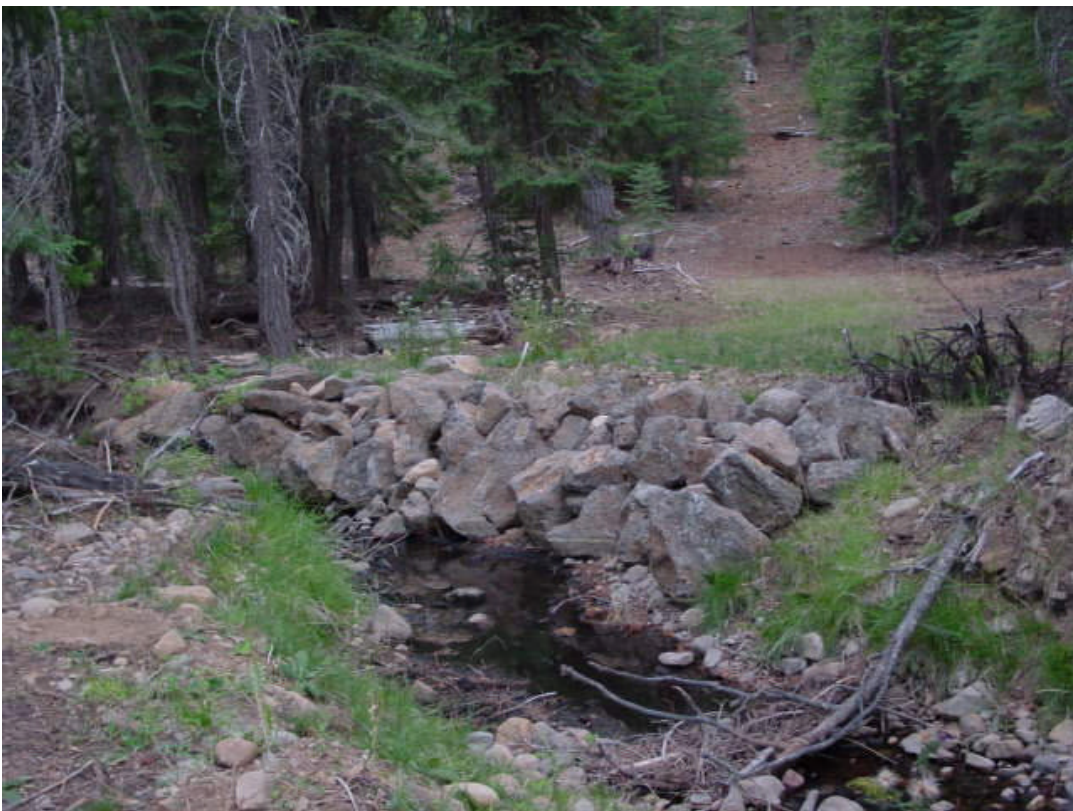
Photo 22.c

Channel erosion and undercut bank trees.
